Observations by the International Tsunami Survey Team Regions VII-VI and V of Chile

Abstract

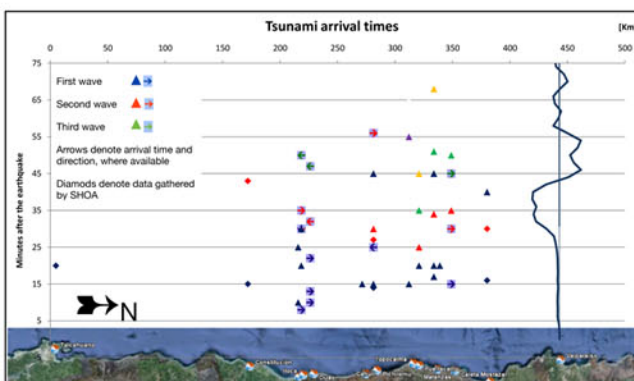
As expected, the results show significant scatter, although some underlying trends are discernible.

For instance, many suggest the occurrence of a first wave propagating from the south (blue triangles). The estimated arrival time appears to increase as northwards.

This is consistent with the tide gage record at Valparaíso, which shows the first signal nearly 25 minutes after the earthquake.

A second wave was reported travelling from the north in locations south of Pichilemu, whereas located north from Pichilemu report it traveling in the opposite direction (red symbols). Consistent with this, the arrival times for this wave seem to have a minimum near Pichilemu.

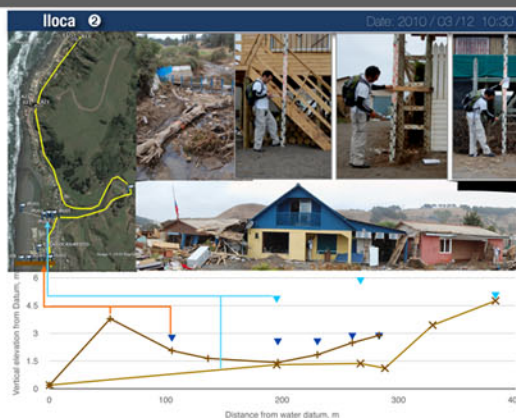
Iloca sustained widespread damage, although the maximum run up was about 4.7 m. Debris floating bodies caused damage to the small dam used for the town's water supply, located a few kilometers inland along the Iloca river. Although some of the residential areas were protected by a coastal dune, the tsunami entered from the back side of the dune. Despite the damage, no casualties were reported here due to the appropriate community response and training.

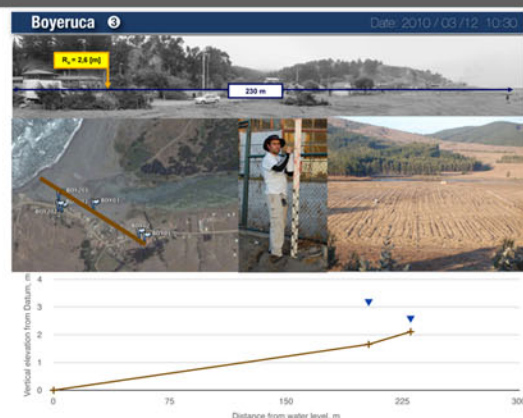
The coastal configuration of Boyeruca is typical of central Chile, where the interaction between a stream and waves tends to form bars and dunes at the discharge. These were completely reconfigured due to the tsunami, which propagated several kilometers inland as shown by boats found in crop fields. The most destructive waves were reported to be of bore-like nature approaching from the north.

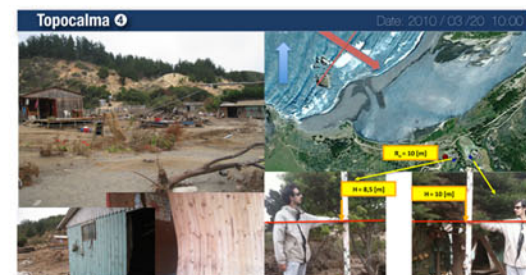
Topocalma is located a few kilometers north from Pichilemu. Here locals reported the wave approaching directly into the beach. Run up levels showed a significant increase with respect to communities located further south, reaching up to 10 m locally.

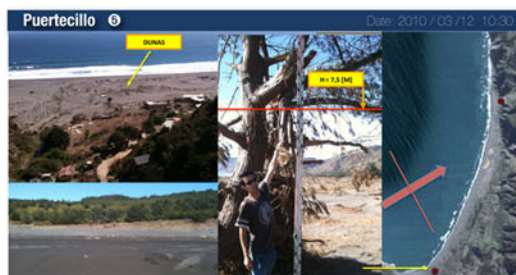
Puertecillo reported waves propagating from the south, with run up levels reaching up to 10.5 m. A casualty was reported in this area.

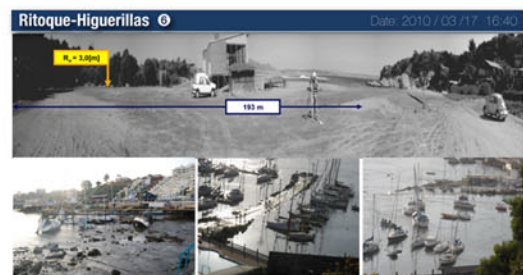
While the passage of the first waves went unnoticed, the effects of the tsunami could be felt several hours after the earthquake. Locals watched and recorded several flooding events at 8 am, nearly 5 hours after the earthquake. Some of these late events had run up levels up to 3 m, and caused some damage on coastal infrastructure.
